Chassis Investigation Report

Client: Mr Bump
Car: Porsche Boxster S 987
Registration: ***** vin WPOZZZ98Z5U*****
Mileage: 44744miles

Investigation type

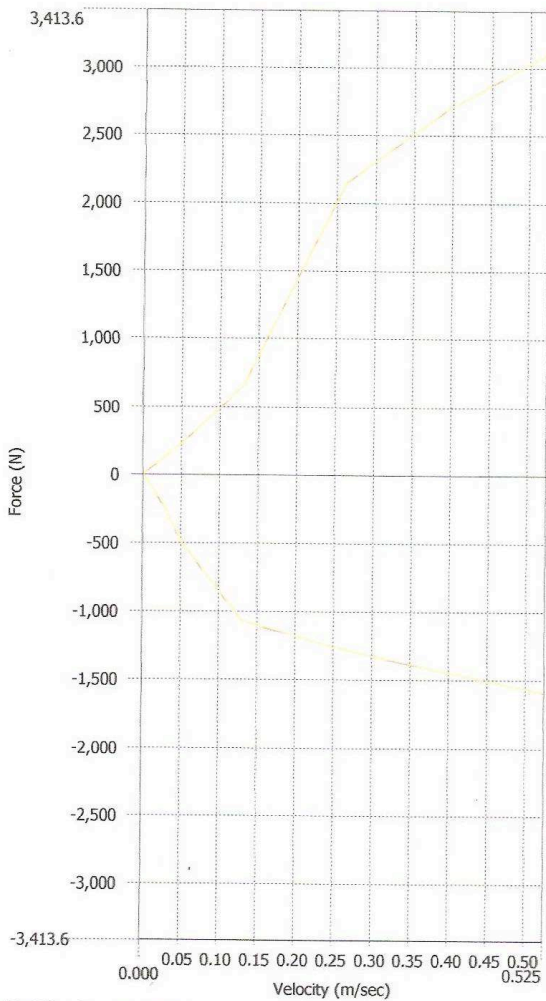
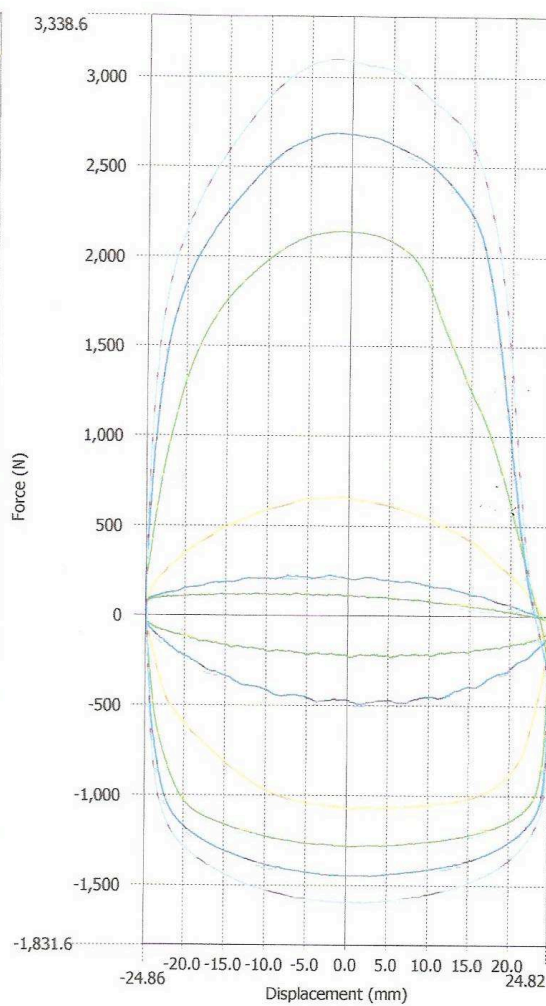
Both dampers show defective compression curves with a lower force than that defined by Bilstein specification for damper type. Damper 3 has a severe malfunction in the compression in the transition from slow to high speed bump and is likely to be responsible for knocking sound.

Damper 2 is failing. Damper 3 has failed internally.

Stroke: N/A Peak Velocity: 0.525 m/sec Test Speed: N/A Gas Force: -238.18 N Shaft Diameter: 16.002 mm / ((2)² x pi) = Gas Pressure: -11.84 Bar Seal Drag: -51.13 N Temp: -17.78 C

Field	Data
Customer Name	Centre Of Gravity
Shock ID	Porsche Boxter
Vehicle	
Location	NSR 3
Gas Fill Pressure	
Gas Piston Offset	
Oil	
Test Velocity	0.52 M/S
Compression Setting	
Rebound Setting	
Preload Setting	
Notes

Requested Velocity	Compression Velocity	Compression Force	Rebound Velocity	Rebound Force
N/A	0.000	0.00	0.000	0.00
0.026	-0.027	-231.00	0.027	117.02
0.050	-0.050	-491.00	0.051	225.96
0.130	-0.130	-1,074.75	0.131	652.77
0.260	-0.264	-1,285.27	0.262	2,145.00
0.390	-0.395	-1,447.00	0.392	2,885.48
0.520	-0.525	-1,594.07	0.523	3,103.25

The recommended action is to replace both rear dampers due primarily to them having leaked oil.

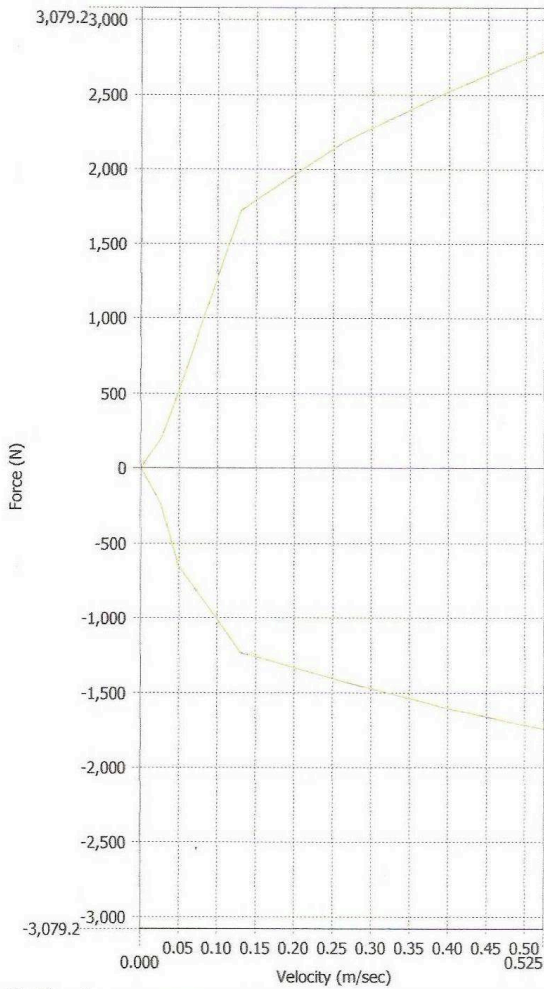
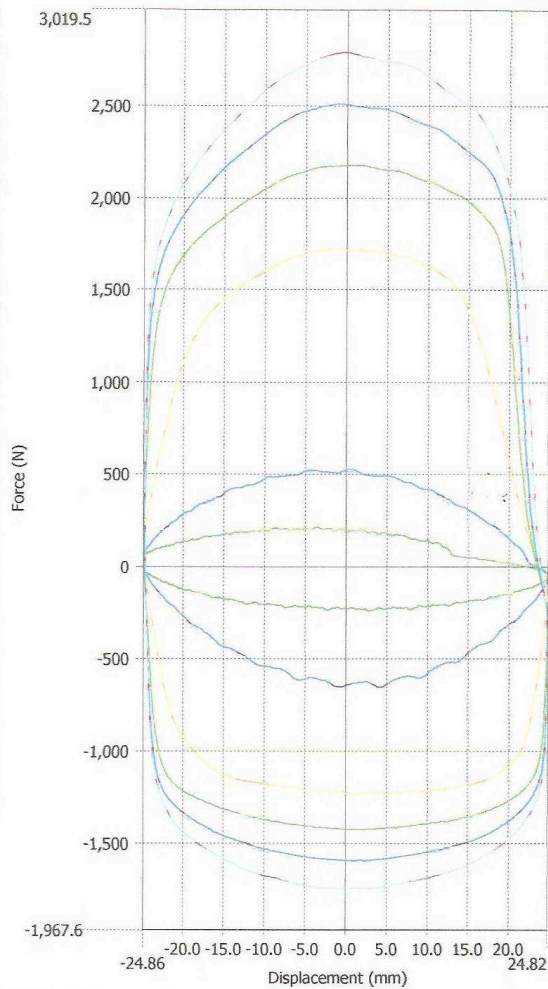
Stroke: N/A Peak Velocity: 0.525 m/sec Test Speed: N/A Gas Force: -218.63 N Shaft Diameter: $\frac{16.002 \text{ mm}}{2} \times \pi =$ Gas Pressure: -10.87 Bar Seal Drag: -38.33 N Temp: -17.78 C

Field	Data
Customer Name	Centre Of Gravity
Shock ID	Porsche Boxter
Vehicle	
Location	NSR 2
Gas Fill Pressure	
Gas Piston Offset	
Oil	
Test Velocity	0.52 M/S
Compression Setting	
Rebound Setting	
Preload Setting	
Notes

Requested Velocity	Compression Velocity	Compression Force	Rebound Velocity	Rebound Force
N/A	0.000	0.00	0.000	0.00
0.026	-0.026	-237.13	0.027	198.99
0.052	-0.052	-474.26	0.053	397.98
0.130	-0.131	-1,233.88	0.130	1,724.71
0.260	-0.263	-1,425.04	0.262	2,177.47
0.390	-0.395	-1,595.21	0.394	2,511.03
0.520	-0.524	-1,740.10	0.525	2,799.24
