Chassis Investigation Report

Client: Mr Bump
Car: Porsche Boxster S 987
Registration: ***** vin WPOZZZ98Z5U*****
Mileage: 44744miles

Investigation type

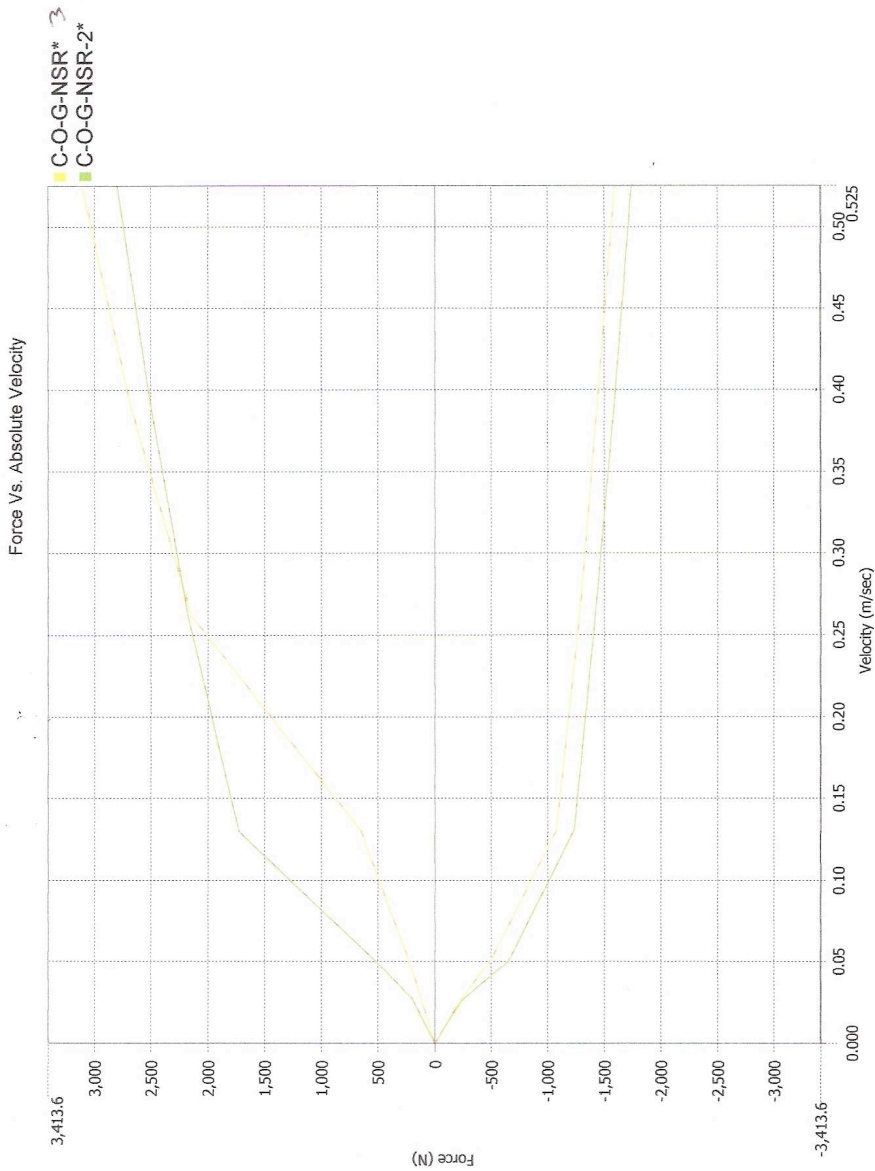
5. Damper test; Dampers cooled in cold water bath prior to test. Using a standard post-build damper test routine on a SPA Damper Dynamometer; both rear dampers tested for compression and bump force for programmed shaft velocity speeds. See attached dyno results. Results logged for damper 2 – offside rear and damper 3 – nearside rear. Damper test was done in default sport mode only (unswitched damper)
 - a. Damper 3 has defective compression curve – inverse knee in transition from low to high speed bump
 - b. Damper 2 and 3 both have shallow compression curves

Both dampers show defective compression curves with a lower force than that defined by Bilstein specification for damper type. Damper 3 has a severe malfunction in the compression in the transition from slow to high speed bump and is likely to be responsible for knocking sound.

Damper 2 is failing. Damper 3 has failed internally.

The recommended action is to replace both rear dampers due primarily to them having leaked oil.
